TECHNICAL REPORT

LAKE MICHIGAN SHORELINE RECESSION AND BLUFF STABILITY IN NORTHEASTERN WISCONSIN: 1996

Bay-Lake Regional Planning Commission
211 North Broadway
Old Fort Square Suite 211
Green Bay, Wisconsin 54303
Project Manager - Dale W. Mohr
Research Assistant - Alex M. Jerabek
and
Geotechnical Consultants:
John A. Chapman
Tuncer B. Edil
David M. Mickelson

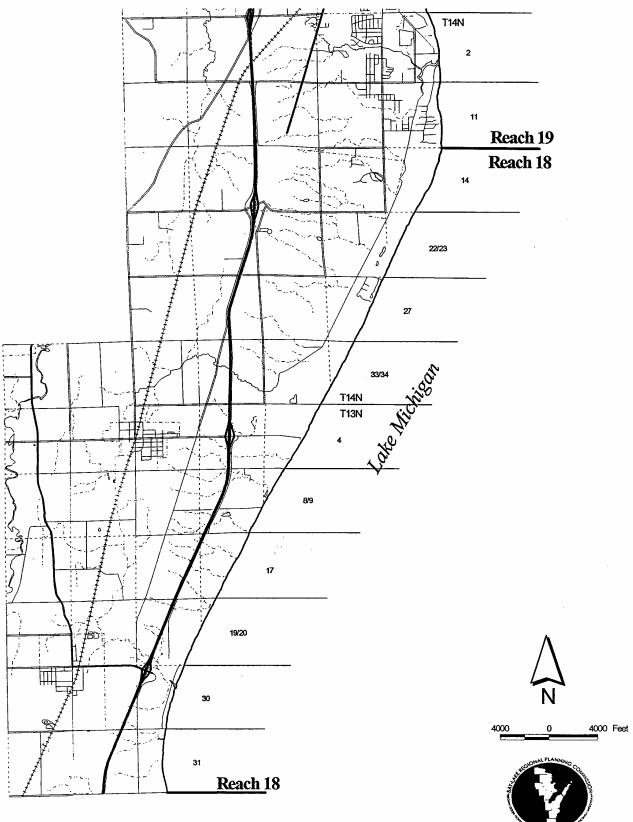
Map III-1 Bluff Analysis Sections Within Reach 18

Profile 77-1 was determined to have a factor of safety of 1.5 in 1977 and predicted to have a circular failure in the upper slope, (Appendix B). This profile is now well vegetated with seeps occurring near the toe. This profile is protected by riprap and has had no bluff top recession since 1975. It now appears stable and unlikely to fail, having a factor of safety of 3.4 with respect to

rotational failures. Profile 77-2 (Appendix B) had a factor of safety of 1.53 in 1977 and was predicted to have a large, circular failure throughout the slope. This profile has now been regraded and is protected by riprap. This profile currently has a factor of safety of 0.96 with respect to rotational failures based on our assumptions.

In 1977 the beach width varied from 35 feet in the southern end, no beach in the middle, and a beach ranging from 15 to 75 feet in the northern end of the section. In 1996 the beach width is recorded as being nonexistant to 16 feet.

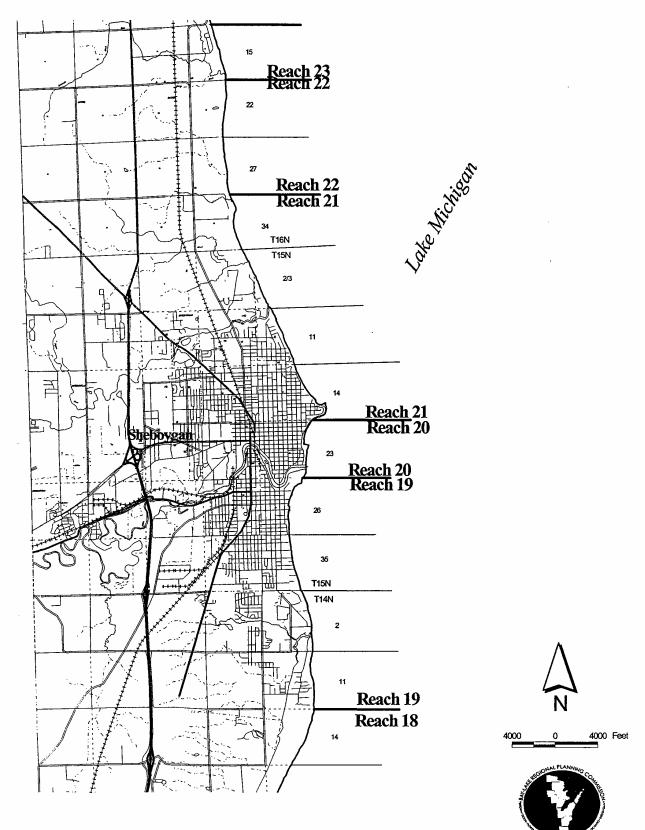
Map III-2 Bluff Analysis Sections Within Reach 19, 20, 21, & 22

Erosion zone 27b extends from 27.6 to 27.9. This zone has large rotational failures and more vegetation cover than the other zones in this section. Profile 80-38 shows little bluff top recession since 1975. Profile 80-38 has a current factor of safety of 1.80 with respect to rotational failures (Appendix A). Shallow translational failures are likely, while rotational failures are possible within zone 27b. Zone 27c extends from 27.9 to the north end of the section. This zone has translational failures and 50 percent vegetation coverage of grasses.

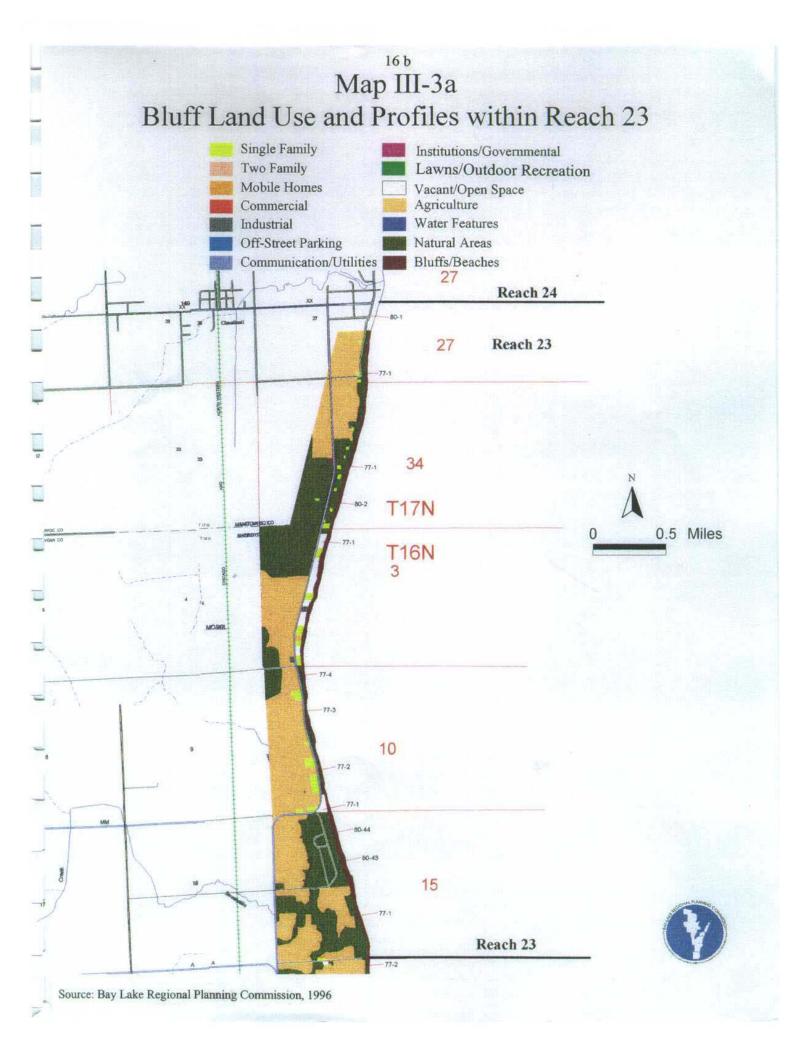
Map III-3 Bluff Analysis Sections Within Reach 23 & 24

to upper slope. The bluff exhibits translational and shallow rotational failures. There are two profiles in this zone. Profile 77-1 had a factor of safety of 1.41 in 1977 (Appendix A & B). This analysis predicted failure to occur throughout the entire slope. The bluff now shows translational failures and little vegetation and has a factor of safety of 0.54 with respect to rotational failures. Profile 77-2 had a factor of safety of 1.42 in 1977 and was also predicted to have a large circular failure throughout the entire slope. This bluff now exhibits translational failures and is 80 percent vegetated. Profile 77-2 has a current factor of safety of 1.22 with respect to rotational failures. There appears to have been five to eight feet of bluff top recession since 1975 at this profile. Profile 80-4 exhibits translational failures and five to eight feet of bluff top recession since 1975. Profile 80-4 currently has a factor of safety of 1.26 with respect to rotational failures (Appendix A & B).

Erosion zone 22b has a sand and pebble beach ranging from 15 to 20 feet wide. Riprap exists sporadically along the bluff toe in this zone. Rotational failures are possible in this zone, and shallow translational failures are likely to occur.

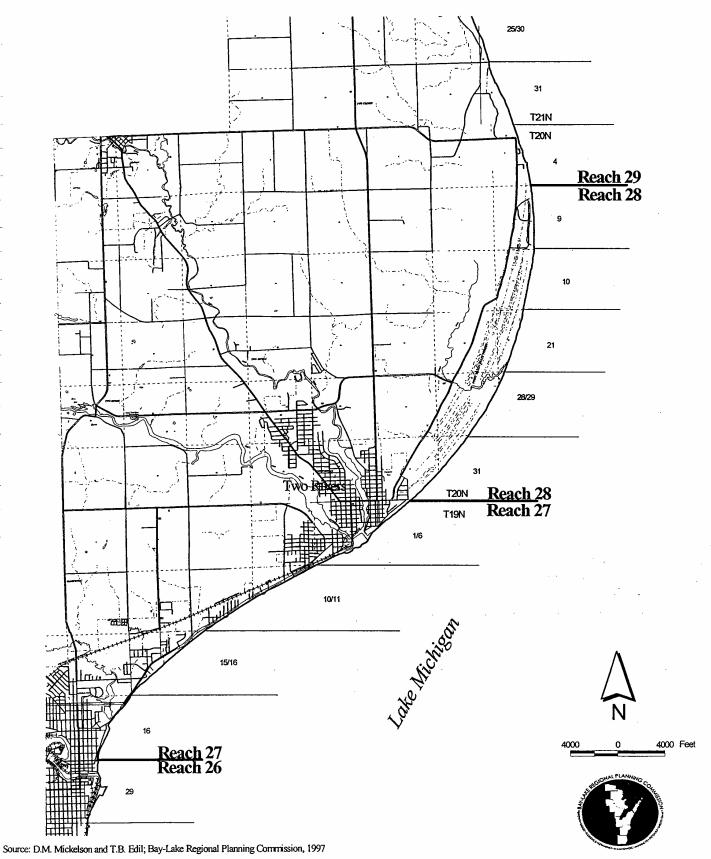
Map III-5
Bluff Analysis Sections Within Reach 27 & 28

Erosion zone 30b extends from 30.2 to 30.6. There is a bluff up to 30 feet high that is poorly vegetated, with less than 40 percent vegetation cover of grasses. The bluff in this zone is failing by block slides, block falls, and translational failures. Seeps are present in the upper three feet of

the bluff and toe erosion appears to be driving the slope failures. Profile 77-1 currently has a factor of safety of 1.3 with respect to rotational failures (Appendix A & B). The factor of safety was 1.97 for this profile in 1977. Zone 30b is likely to have shallow translational failures, and smaller rotational failures are also possible. There is an estimated 15 feet of bluff top recession since 1975 for this zone.
