Bay Beach Restoration Action Plan

Green Bay, Wisconsin

May 31, 2015

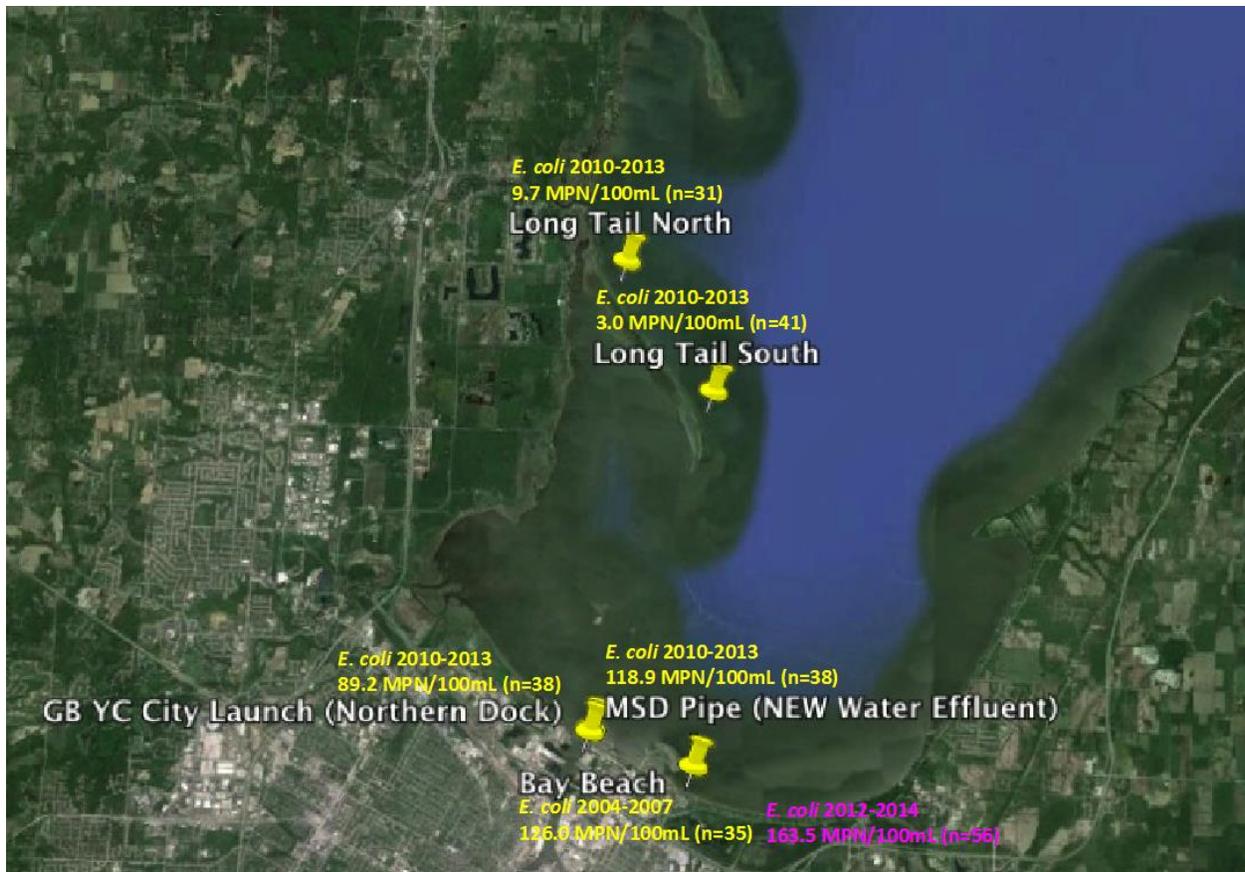
Figure 1. Map of the Bay of Green Bay indicating monitoring sites where NEW Water and UW Oshkosh monitored for *E. coli* over several years. All text in YELLOW indicate these data were collected by NEW Water. All text in PINK indicate data was collected by UW Oshkosh.

In addition to samples collected at Bay Beach, there were sites located on the Fox River and off of Long Tail Island where NEW Water collected water samples and evaluated them for several water quality parameters. Some of these parameters include wind direction and speed, air temperature, rain, relative humidity, turbidity, pH, TDS, total coliforms, and *E. coli*. While these samples were not collected directly at Bay Beach these data can assist in pinpointing potential pollution sources possibly impacting Bay Beach. Figure 1 shows the historical monitoring locations, dates when these sites were monitored for *E. coli*, and mean *E. coli* concentrations. *E. coli* concentrations at each of the monitoring sites were well below the regulatory threshold of 235 MPN/100 mL for posting an advisory at a beach.

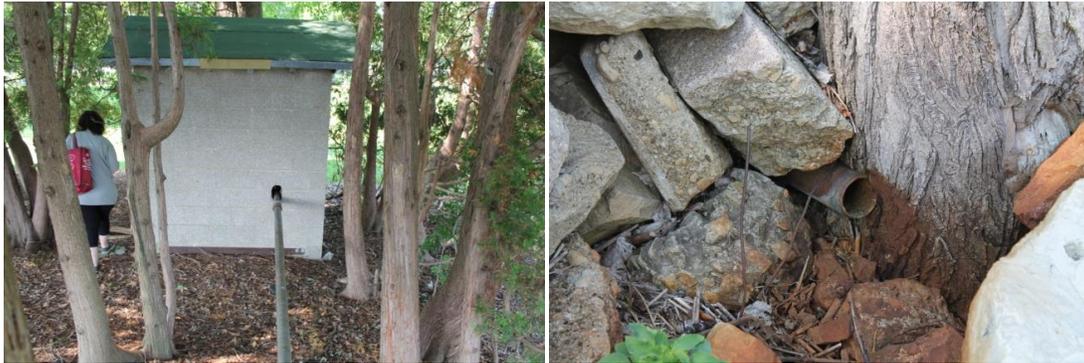
Figure 3. Localized infrastructure may be a point source of pollution.

Annual walking site assessments and intensive sampling/data analysis, conducted as part of the beach sanitary survey and site assessment process, identified potential point (direct) sources of pollution including a pipe extending from a small white concrete block structure which discharges onto the beach at the east end of the small white building (Figure 3).

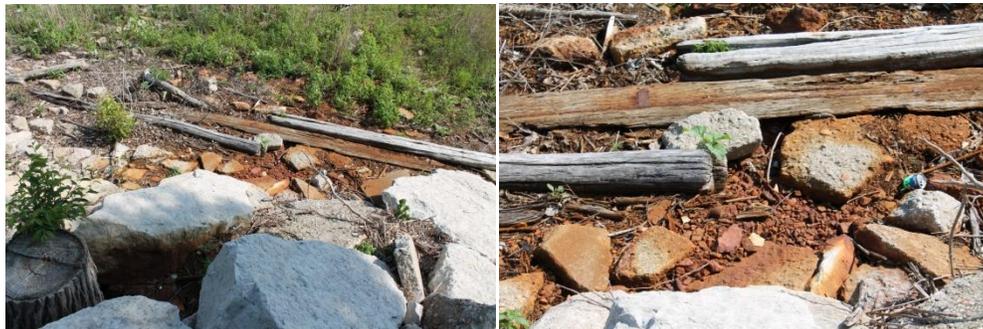
Figure 4. Deposits of rust on beach substrate.

Significant amounts of rusty deposits on trees, rocks and other hard surfaces below the revetment provide evidence of frequent discharge (Figure 4).

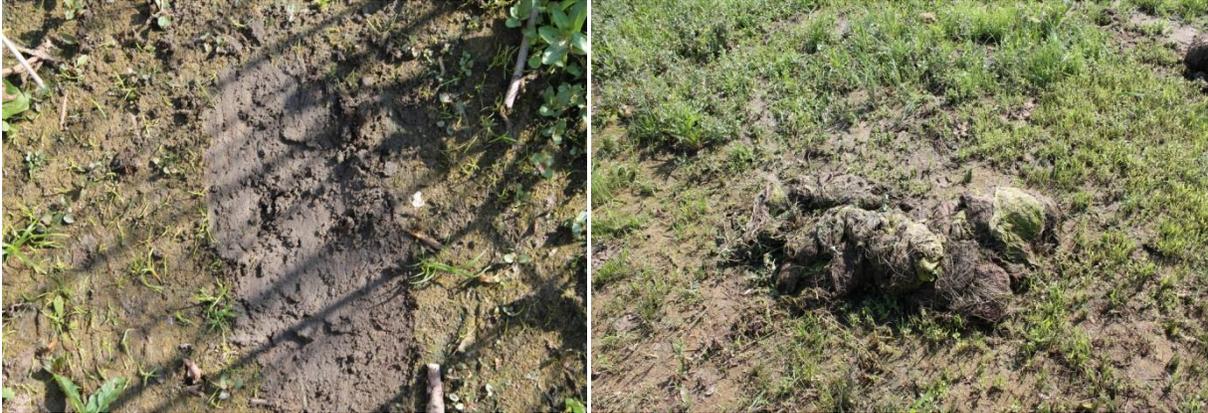
Figure 5. Examples of fine beach sediments with organic matter and stranded algae.

In addition, high waves, onshore winds, and surface runoff were noted as likely mechanisms of transport, contributing non-point source (indirect) pollution to the nearshore waters off of Bay Beach Park. High waves and surface runoff can increase turbidity by suspending or transferring sediment particles into the water column. Therefore, beach sands/sediments and submerged sediments could also be potential non-point sources of pollution (Figure 5). Other potential non-point pollution sources noted were: avian wildlife populations (contributing fecal matter to both the nearshore water and/or beach sands) and algae (*Cladophora*) (stranded mats create a hospitable habitat for bacterial persistence and/or growth, Figure 5).

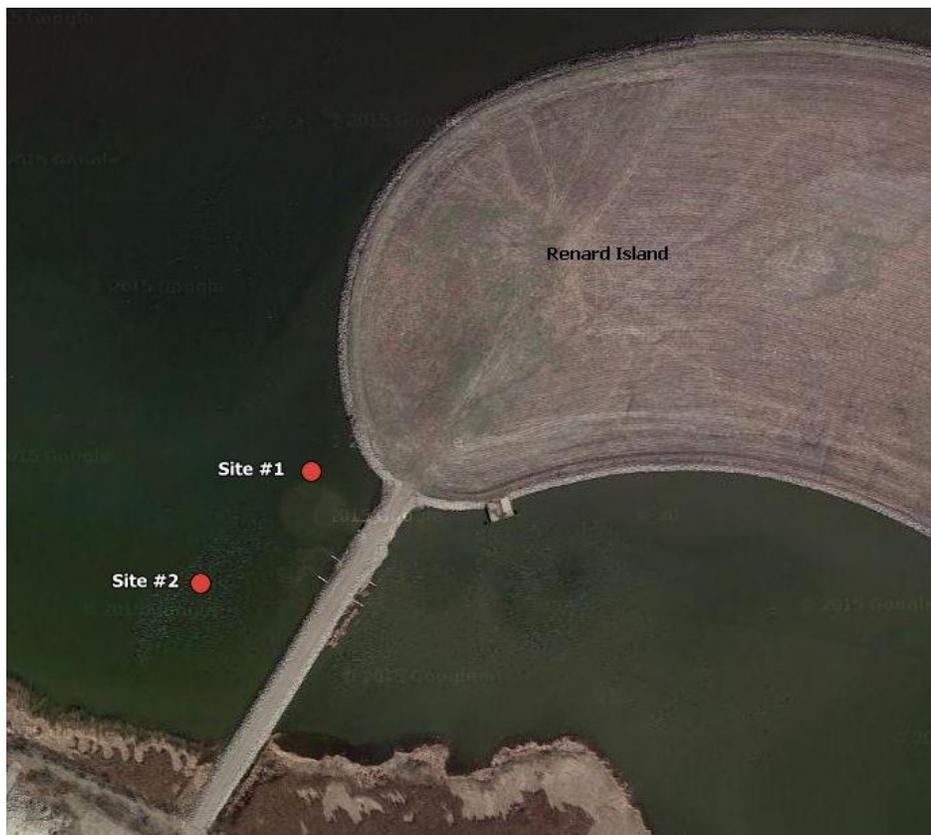
Figure 8. PCB Sampling Sites at Renard Island Causeway (October 2013)

The samples nearest Bay Beach were collected at two sites at the Renard Island causeway on October 11, 2013 (Figure 8). Sampling for PCBs by RTI at Renard Island causeway returned results of concentrations in the range of 45-72 ug/kg dry, with the samples collected nearer Renard Island (Site #1, Figure 8) being <72 ug/kg dry¹ and those closer to the shore just south of Renard Island (Site #2, Figure 8) being <45 ug/kg dry¹. The higher <72 ug/kg dry concentration measured at Renard Island is much lower (>30 times) than the "Great Lakes Protocol" Health Protection Value (Anderson, Amrhein, Shubat & Hesse, 1993) and is also lower (>10 times) than the Minimum Risk Level established by the Agency for Toxic Substance and Disease Registry (Wisconsin Department of Health Services, 2011). Indicating, that the risk of exposure from contaminated sediment at Renard Island is very low. Assuming that the concentrations continue to drop with increased distance from Renard Island, Bay Beach concentrations would be even lower.

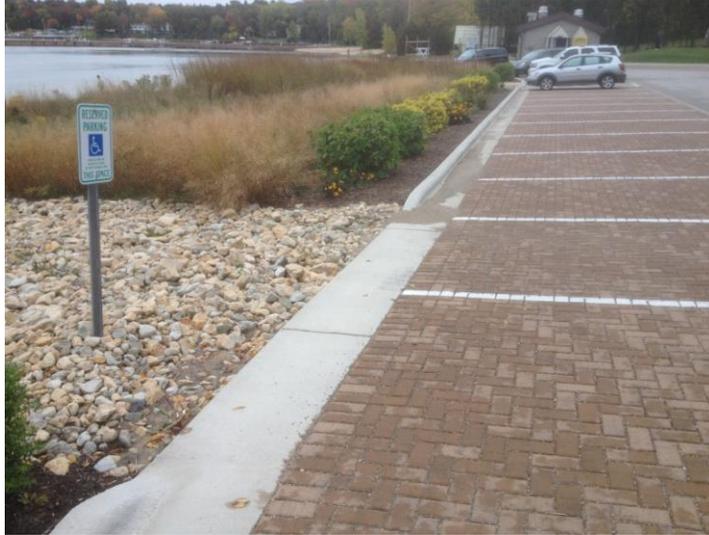
Figure 9: Porous pavement and vegetated swale at a Door County beach parking lot.

Engineering control measures may be either structural (hard engineered features such as permeable pavements, bio-infiltration swales, retention/detention basins, or other infrastructure improvements) (Figure 9) or naturalized (restoring buffer strips, wetlands, dunes and/or planting native vegetation). In some locations, beach redesign plans may call for the removal or alteration of legacy engineered structures, such as jetties, piers, groins or impervious surfaces. At other sites, construction of devices to mimic natural coastal attributes or alteration of existing land features may be needed to elicit necessary water quality improvements. Site specific engineered solutions have been recommended as a result of the intensive monitoring conducted at Bay Beach. The remainder of this section serves to provide a rationale for, and reinforce, the importance of such measures in maintaining or restoring ecosystem health and is meant to be complimentary to the merit report and redesign plan. Appendix D contains a copy of *Beach Engineering Package for Bay Beach* (2014) developed by Miller Engineers & Scientists.

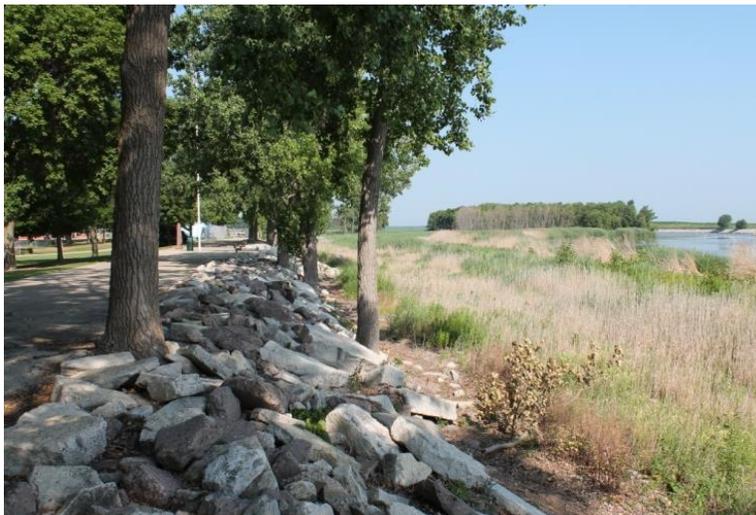
Figure 10. Shoreline erosion control feature at Bay Beach.

High waves and storm surges frequently flood shoreline areas. To guard against future flooding a dike, or revetment, was placed along the shoreline at Bay Beach Park (Figure 10). Historical photographs indicate that the waters of Green Bay abutted the revetment at the time of installation. However, due to successive years of accretion and reliction the shoreline has retreated several meters at times exposing lakebed. The removal of this shoreline erosion control measure is not recommended.

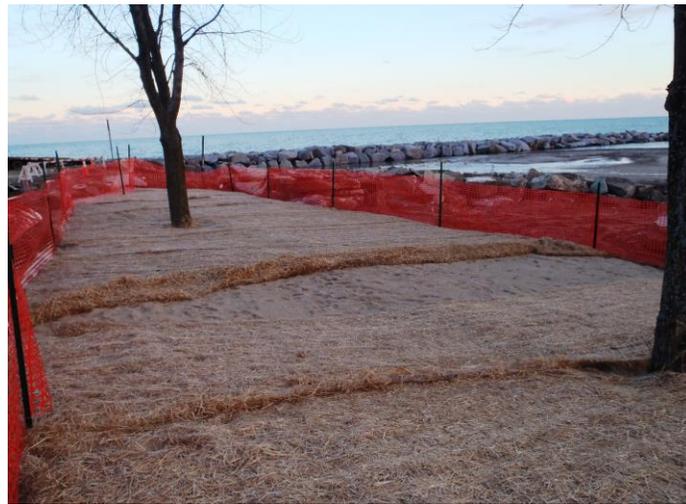
Figure 13. Dunes provide infiltration of urban runoff at Samuel Myers Park (Racine, WI).

Restoration recommendations at Bay Beach make use of green infrastructure to reduce the impact of runoff. Dunes and wetlands serve as an important buffer between terrestrial activities and aqueous environments, improving water quality through a series of chemical, biological and physical processes. In addition to water filtration, they provide habitat for a variety of plant and animal species, are home to unique ecology, reduce flood hazards, lessen erosion, and serve as an important temporary storage element. Improvements to the asphalt pathway will also reduce pooling and shunting of runoff onto the beach.

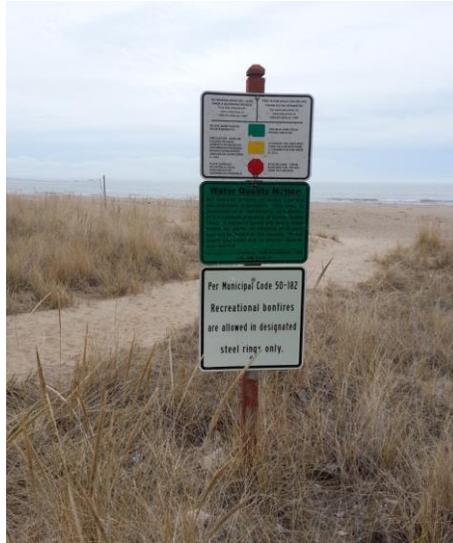
Figure 16. WDNR approved water quality signage and beach rules; Blue Harbor Beach, Sheboygan, WI.

The use of color-coded flags, which coordinate with approved signage, increases visibility. WDNR approved signage should be installed at popular public access points, possibly two or three signs depending on size and layout of the beach. The statewide signage procedure calls for the default water quality testing notification sign (green) to be posted continuously (Figure 16). Water quality results signs (yellow or red) must accompany the notification sign when water quality conditions occur that could negatively impact human health. The use of the blue sign is optional.

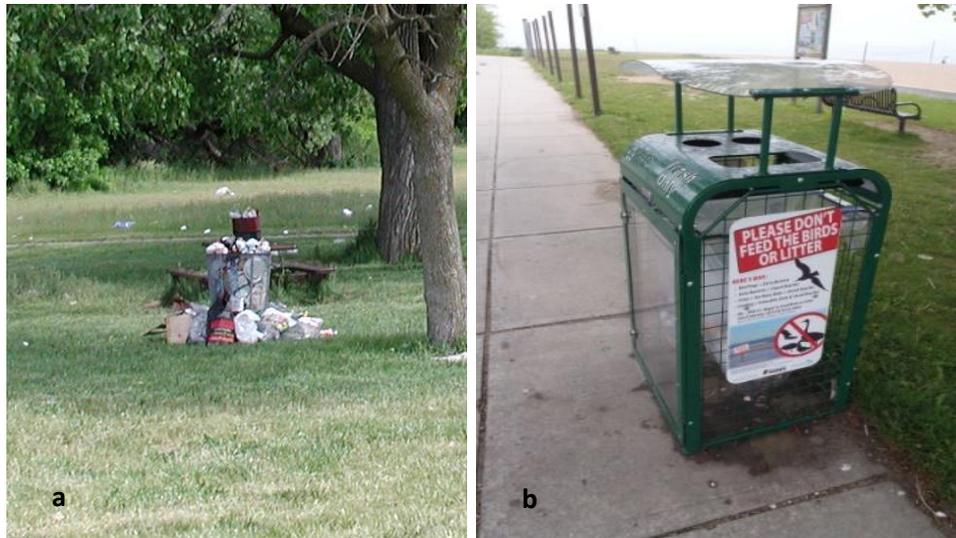
Figure 17 (a): Overflowing open waste receptacle; prone to attracting gulls and scatter windblown debris.

The accumulation of litter decreases aesthetic appeal and can present a hazard to wildlife and human health. Food-related litter also attracts nuisance wildlife (Figure 17a). The use of waste receptacles with liners and covers is recommended to deter wildlife and prevent accidental release (Figure 14b). The presence of litter can be controlled through active removal, public education and enforceable municipal ordinances. A sufficient number of waste receptacles and recycling bins should be placed in the park and on the beach, within easy reach of beach patrons, and emptied in an adequate timeframe depending on usage. The use of solar trash compacters can reduce the frequency with which waste receptacles need to be emptied. Waste receptacles are also a great place to post public information (Figure 17b). Event-based beach clean-ups can be coordinated with volunteer or academic organizations with a service component to help manage the accumulation of debris.

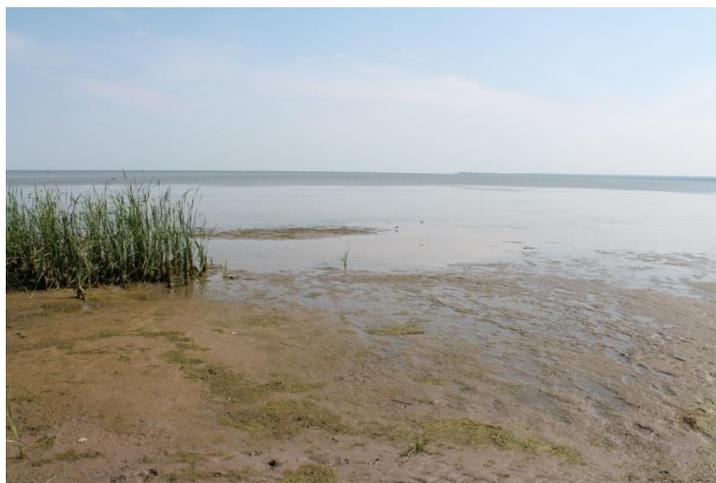
Figure 18. *Phragmites* are well managed on private property adjacent to Bay Beach.

Phragmites was the predominant species at Bay Beach. Eradication efforts, including repeated herbicide applications and manual removal by volunteers and/or City of Green Bay park staff, can reduce the stands by roughly 80% or more. Mechanical removal is not effective as a standalone treatment option because shoots may sprout from underground rhizomes and root fragments within the soil. Mechanical removal, in conjunction with an imazapyr and/or glyphosate application to the stems in late summer (when the shoots transfer carbohydrates to the root system), has been successful. The existing stands east of Bay Beach have been well managed by private landowners, and little to no *Phragmites* remains (Figure 18).

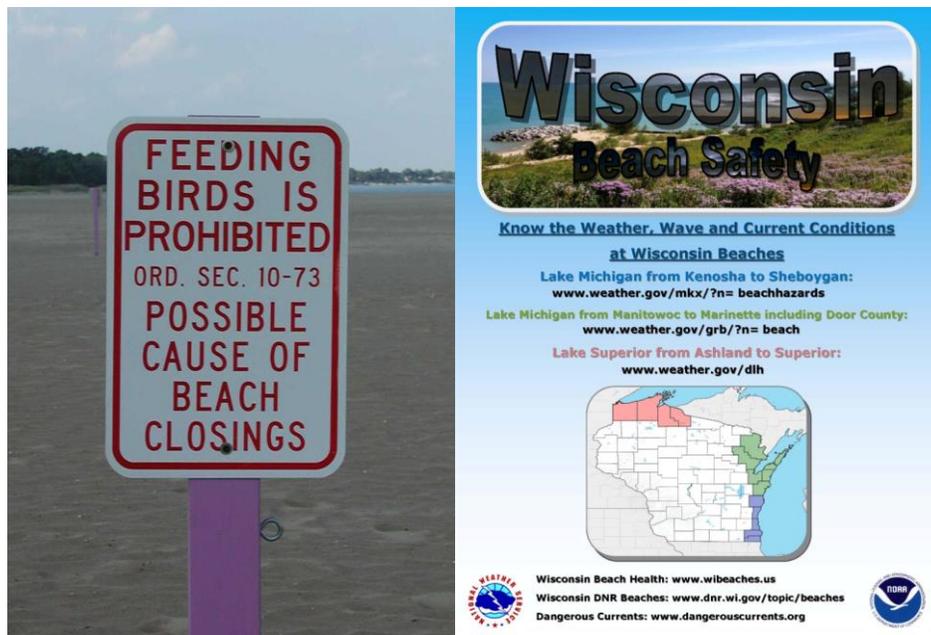
Figure 19. Examples of informational beach signage.

Besides water quality data, other informational/educational signs and enforceable ordinances should be visible at the beach (Figure 19). Examples of other notices include:

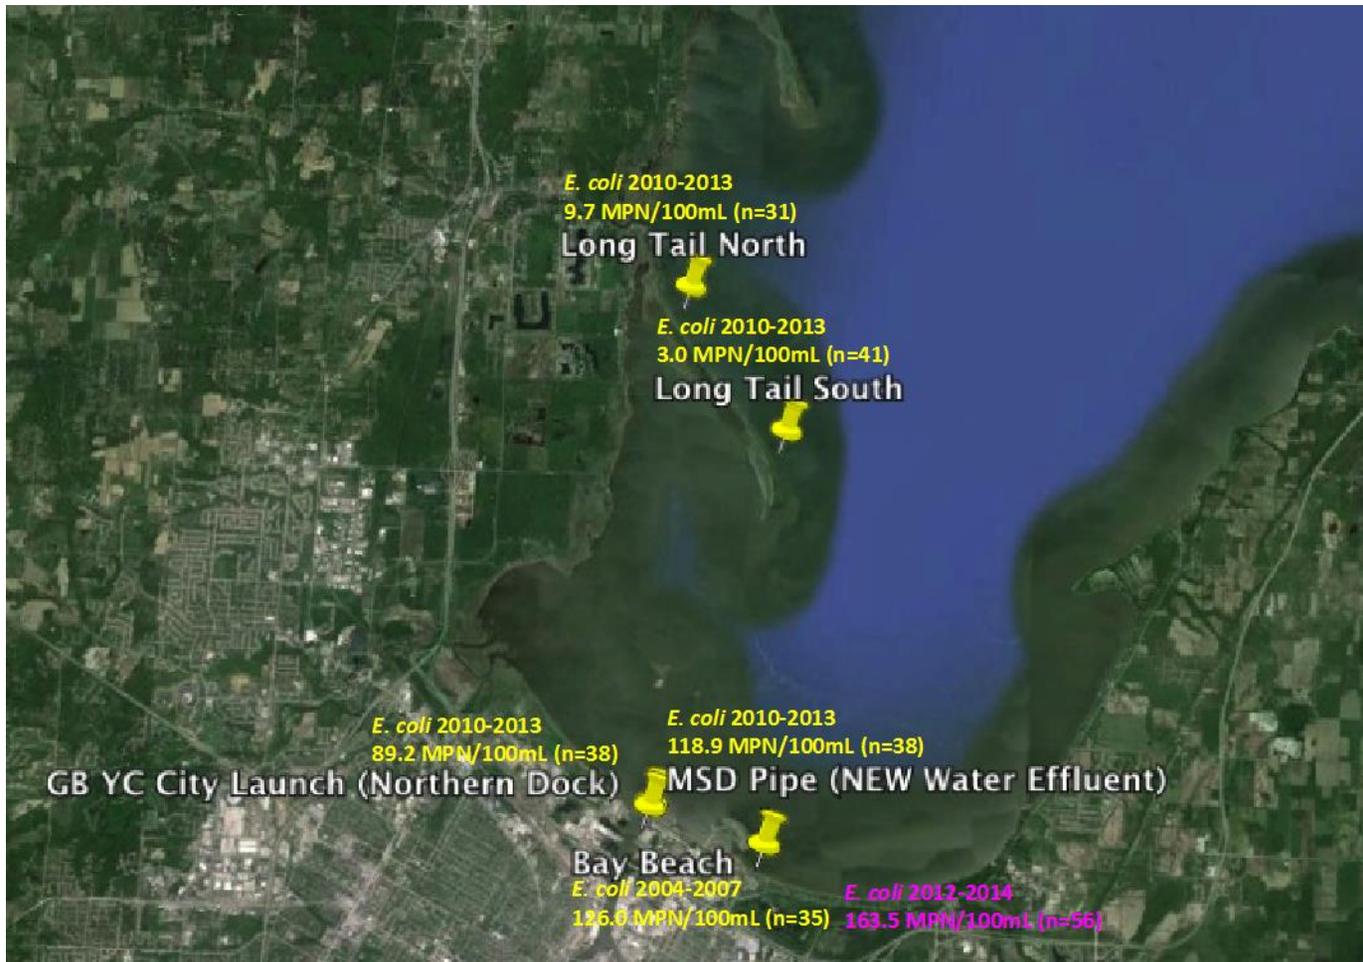
Figure 1. Map of the Bay of Green Bay indicating monitoring sites where NEW Water and UW Oshkosh monitored for *E. coli* over several years. All text in YELLOW indicate these data were collected by NEW Water. All text in PINK indicate data was collected by UW Oshkosh.

In addition to samples collected at Bay Beach, there were sites located on the Fox River and off of Long Tail Island where NEW Water collected water samples and evaluated them for several water quality parameters. Some of these parameters include wind direction and speed, air temperature, rain, relative humidity, turbidity, pH, TDS, total coliforms, and *E. coli*. While these samples were not collected directly at Bay Beach these data can assist in pinpointing potential pollution sources possibly impacting Bay Beach. Figure 1 shows the historical monitoring locations, dates when these sites were monitored for *E. coli*, and mean *E. coli* concentrations. *E. coli* concentrations at each of the monitoring sites were well below the regulatory threshold of 235 MPN/100 mL for posting an advisory at a beach.

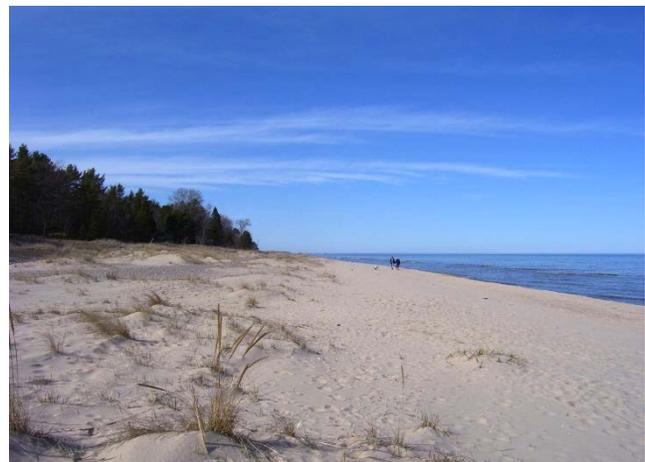
An example of what a “healthy beach” should look like. Note the small dune features, dune grass, and sloping beach.

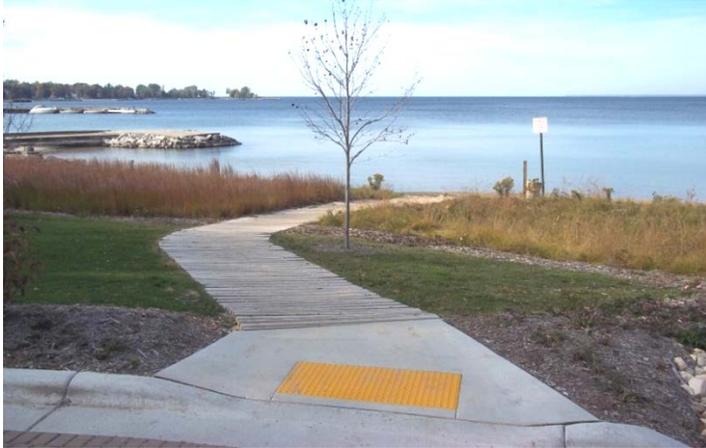
Cord walk pathways are one alternative for public access points to the beach.

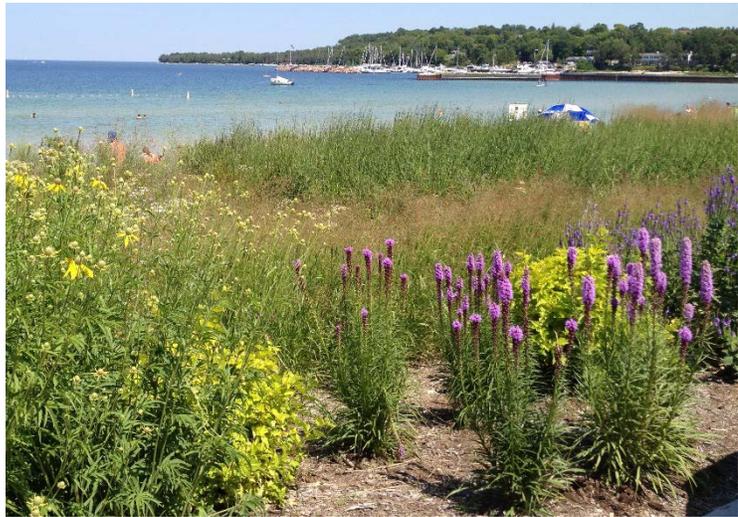
Example of native vegetation plantings

Native vegetation is incorporated into all of the beach redesign elements for a variety of reasons. The root systems of most native plants are very deep and help water soak into the ground, thereby increasing water infiltration and reducing runoff. These root systems also hold soil in place, reducing erosion. Native species are also inherently low maintenance, resulting in saving of time, money and energy. They are adapted to local conditions, which makes them vigorous and resistant to most pests and diseases. Once these plants are established they require minimal care.

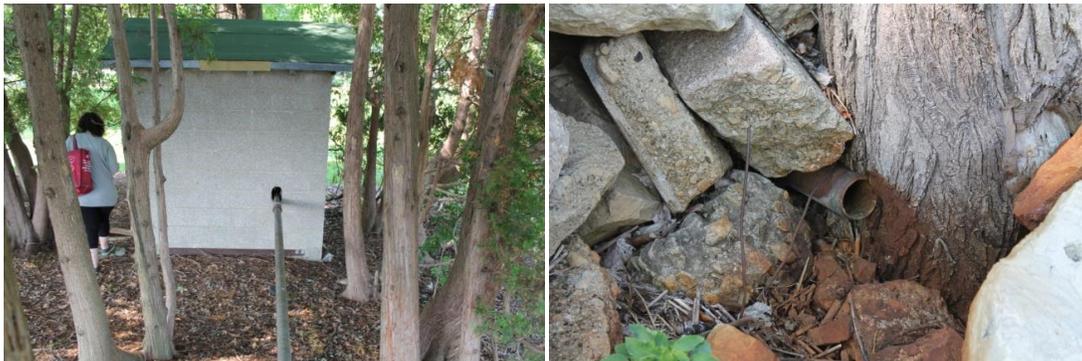
Figure 1. Localized infrastructure may be a point source of pollution.

Potential Pollution Sources: Annual walking site assessments and intensive sampling/data analysis, conducted as part of the beach sanitary survey and site assessment process (2012-2014), identified potential point (direct) sources of pollution including a pipe extending from a concrete block structure which discharges onto the beach at the east end of the white building (Figure 1).

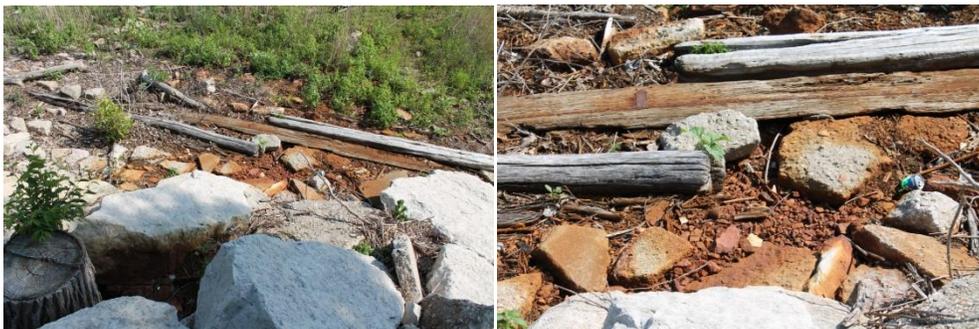
Figure 2. Deposits of rust on beach substrate.

Significant amounts of rusty deposits on trees, rocks and other hard surfaces below the revetment provide evidence of frequent discharge (Figure 2).

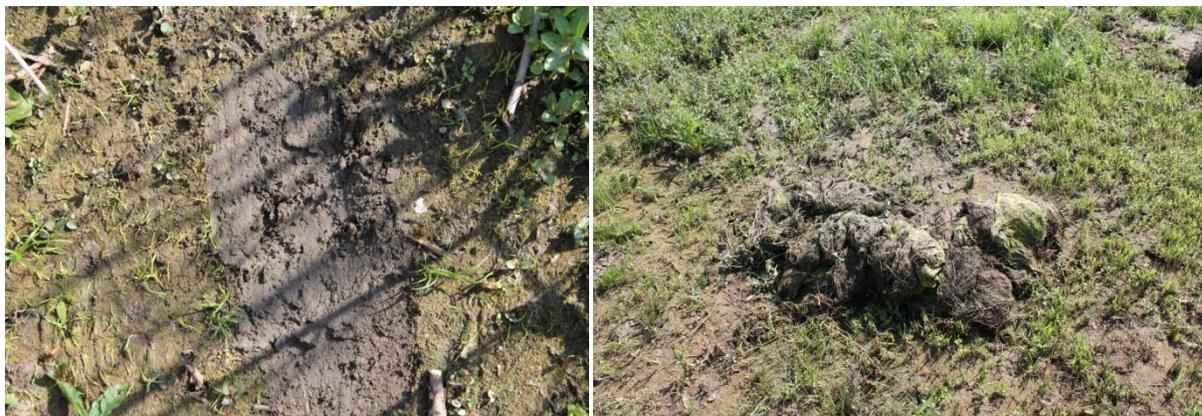
Figure 3. Examples of fine beach sediments with organic matter and stranded algae.

In addition, high waves, onshore winds, and surface runoff were noted as likely mechanisms of transport, contributing non-point source (indirect) pollution to the nearshore waters off of Bay Beach Park. High waves and surface runoff can increase turbidity by suspending or transferring sediment particles into the water column. Therefore, beach sands/sediments and submerged sediments could also be potential non-point sources of pollution (Figure 3). Other potential non-point pollution sources noted were: avian wildlife populations (contributing fecal matter to both the nearshore water and/or beach sands) and algae (*Cladophora*) (stranded mats create a hospitable habitat for bacterial persistence and/or growth, Figure 3).

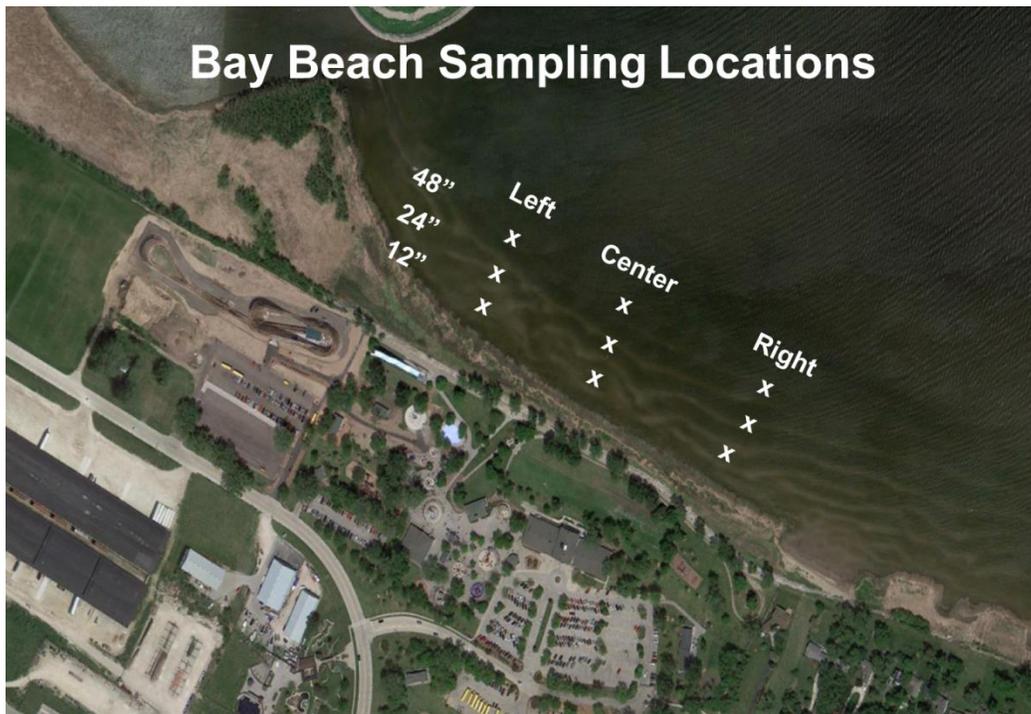
Figure 4. Bay Beach sampling locations.

A sample plan was developed based on the initial site assessment to evaluate all potential pollution sources. Routine sanitary surveys (RSS) were conducted for Bay Beach two times per week from 2012 to 2014. Each survey consisted of recording general beach conditions including air and water temperature, wind speed and direction, rainfall and intensity, weather conditions, wave height and intensity, and alongshore current and speed. Water quality was measured by collecting water samples at various transects (north, center, and south) and depths (12 inches, 24 inches, and 48 inches) and analyzing them for total coliforms, *Escherichia coli* (*E. coli*), and turbidity (Figure 4). In addition to spatial sampling, a water sample was collected at the center of the beach at 24 inches and analyzed for microcystin toxin (Enviroligix ELISA Quantiplate; Portland, ME) each time a

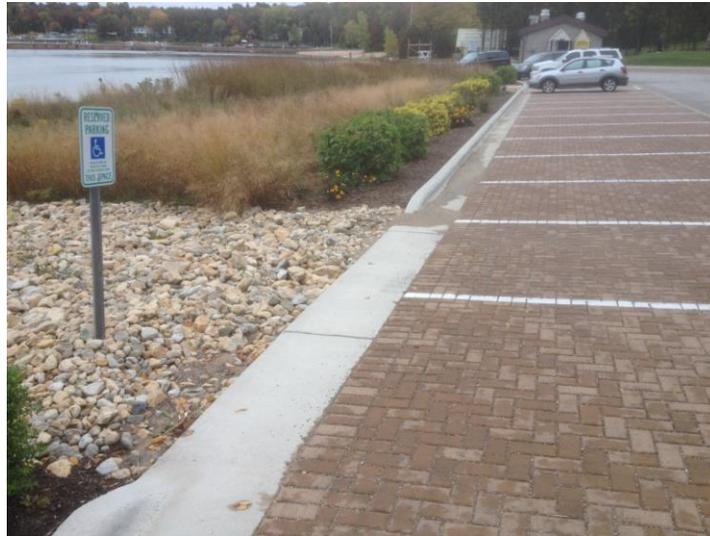
Figure 7: Porous pavement and vegetated swale at a Door County beach parking lot.

Engineering control measures may be either structural (hard engineered features such as permeable pavements, bio-infiltration swales, retention/detention basins, or other infrastructure improvements) (Figure 7) or naturalized (restoring buffer strips, wetlands, dunes and/or planting

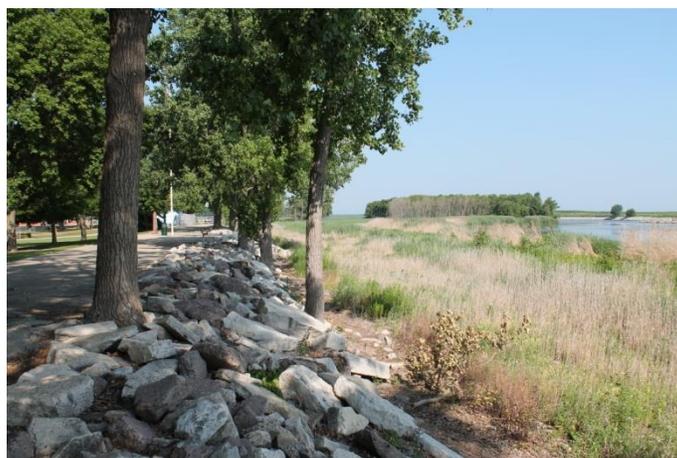
Legacy Engineered Structures. High waves and storm surges frequently flood shoreline areas. To guard against future flooding a dike, or revetment, was placed along the shoreline at Bay Beach Park (Figure 8). Historical photographs indicate that the waters of Green Bay abutted the revetment at the time of installation. However, due to successive years of accretion and reliction the shoreline has retreated several meters, exposing lakebed. The removal of this shoreline erosion control measure is not recommended.

Figure 8. Shoreline erosion control feature at Bay Beach.

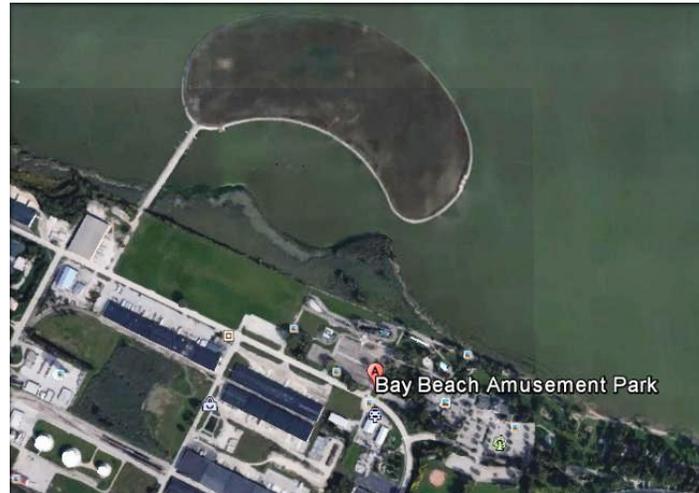
To the west and north of Bay Beach Park lies Renard Island. Renard Island is connected to the mainland by a causeway (Figure 9). While the removal of the causeway may not be permissible or desirable, culverts could be installed to improve circulation in the nearshore area off of Bay Beach. Improving circulation could reduce conditions which result in moderate levels of microcystin.

Figure 9: Renard Island and causeway.

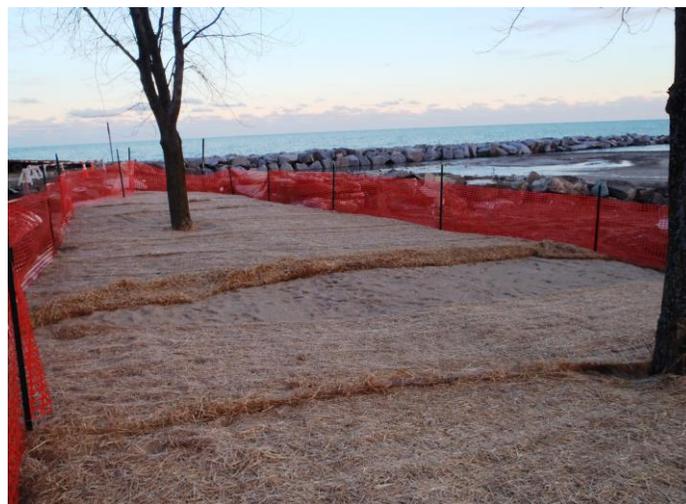
Figure 10: Dunes provide infiltration of urban runoff at Samuel Myers Park (Racine, WI).

Structural and naturalized engineering solutions frequently attempt to address loss of natural coastal features through the implementation of design features that mimic the environment by reducing, retaining and/or infiltrating direct stormwater discharge and surface runoff, for example at Samuel Myers Park in Racine, WI (Figure 10).

Structural and naturalized engineering solutions frequently attempt to address loss of natural coastal features through the implementation of design features that mimic the environment by reducing, retaining and/or infiltrating direct stormwater discharge and surface runoff, for example at Samuel Myers Beach in Racine, Wisconsin (Figure 13).

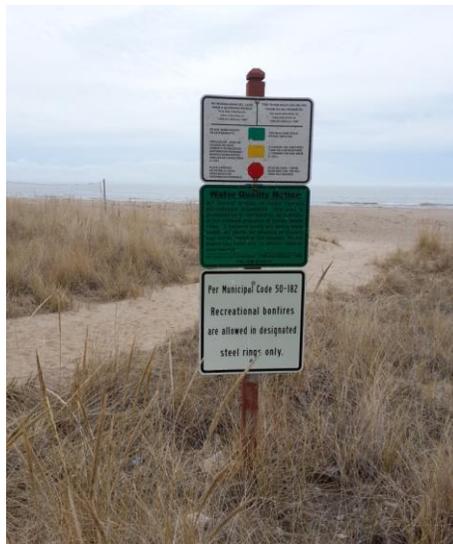
Figure 13. WDNR approved water quality signage and beach rules; Blue Harbor Beach, Sheboygan, WI.

The use of color-coded flags, which coordinate with approved signage, increases visibility. WDNR approved signage should be installed at popular public access points, possibly two or three signs depending on size and layout of the beach. The statewide signage procedure calls for the default water quality testing notification sign (green) to be posted continuously (Figure 13). Water quality results signs (yellow or red) must accompany the notification sign when water quality conditions occur that could negatively impact human health. The use of the blue sign is optional.

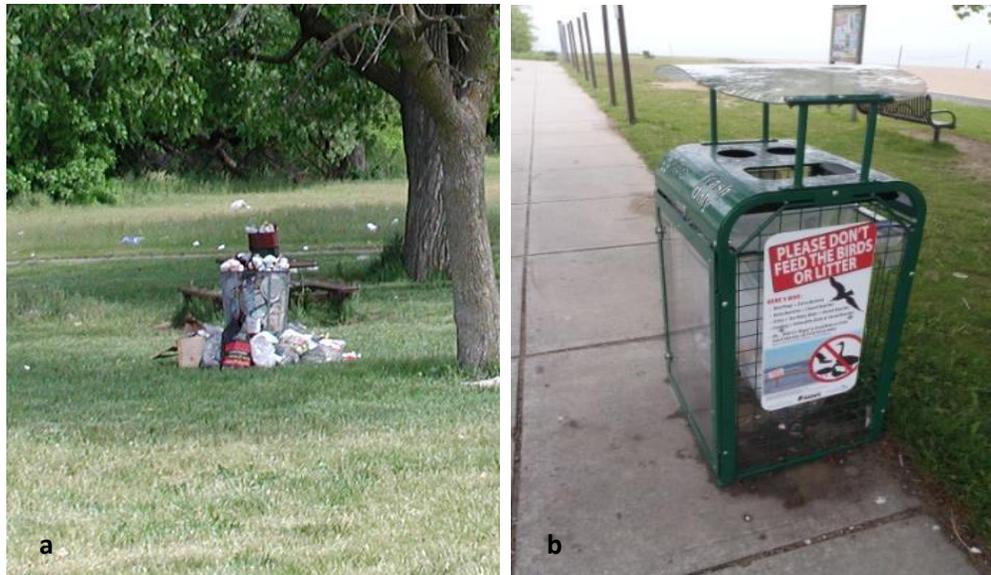
Litter Removal: The accumulation of litter decreases aesthetic appeal and can present a hazard to wildlife and human health. Food-related litter also attracts nuisance wildlife (Figure 14a). The use

of waste receptacles with liners and covers is recommended to deter wildlife and prevent accidental release (Figure 14b). The presence of litter can be controlled through active removal, public education and enforceable municipal ordinances. A sufficient number of waste receptacles and recycling bins should be placed in the park and on the beach, within easy reach of beach patrons, and emptied in an adequate timeframe depending on usage. The use of solar trash compacters can reduce the frequency with which waste receptacles need to be emptied. Waste receptacles are also a great place to post public information (Figure 14b). Event-based beach clean-ups can be coordinated with volunteer or academic organizations with a service component to help manage the accumulation of debris.

Figure 14 (a): Overflowing open waste receptacle; prone to attracting gulls and scatter windblown debris.
Figure 14 (b): Waste receptacle designed to deter gulls as well as provide public information.

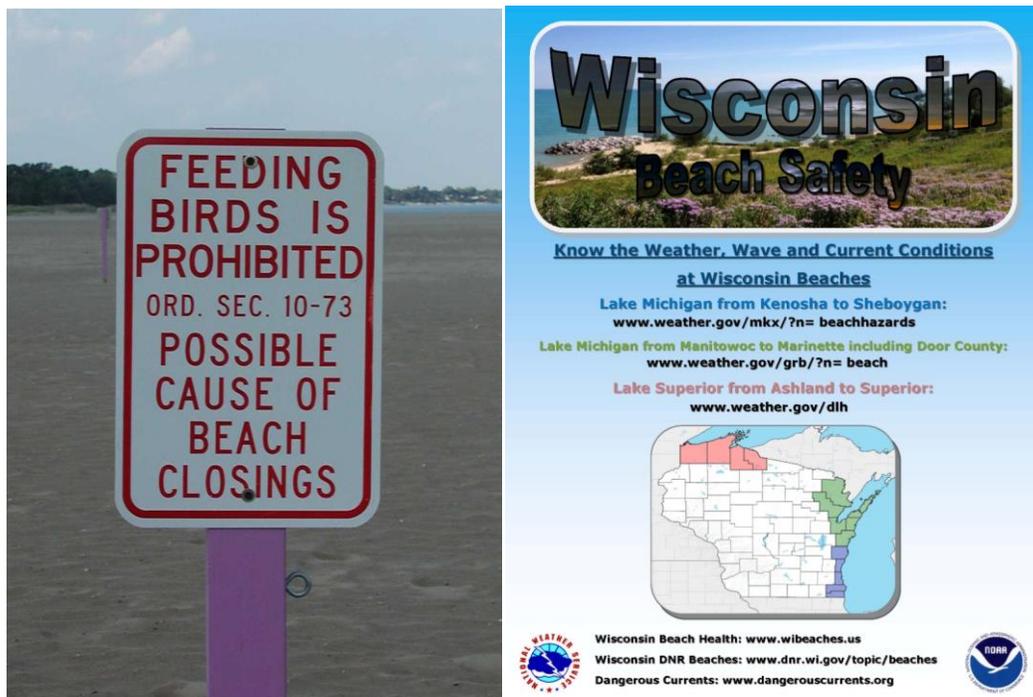
Besides water quality data, other informational/educational signs and enforceable ordinances should be visible at the beach (Figure 16). Examples of other notices include:

Figure 16. Examples of informational beach signage.
